A study on reinforcement corrosion of concrete structures near coastal areas of Oman

Halima Ghulam Al-Balushi
Himanshu Gaur

Middle East College
Middle East College

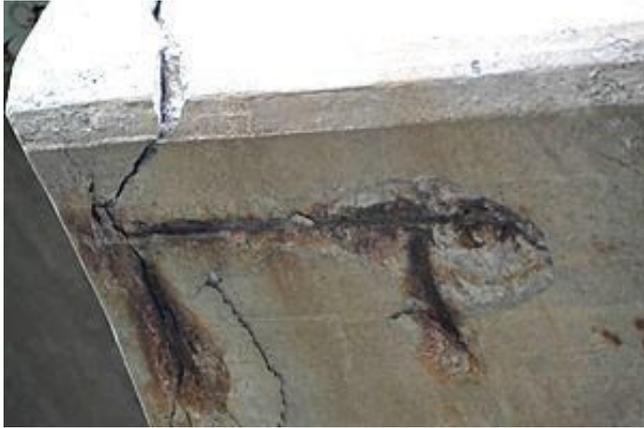
Figure 1. *The effect of corrosion on concrete*

In this research the effect of chloride ion is studied on portland cement concrete and steel reinforcement as well. The effect of chloride in low concentration is very small on physical properties of concrete but it can cause corrosion of reinforcement steel in concrete, however, the effect is increased when the concentration of chloride is high. In addition, high concentration of chloride in low temperature causes cracking and expansion in concrete. the devolusion is comprises through the formation of calcium oxychloride salts. Moreover, the destroying mechanism is occur because of the calcium oxychloride salts (**Birnin and Saidu 2006**).

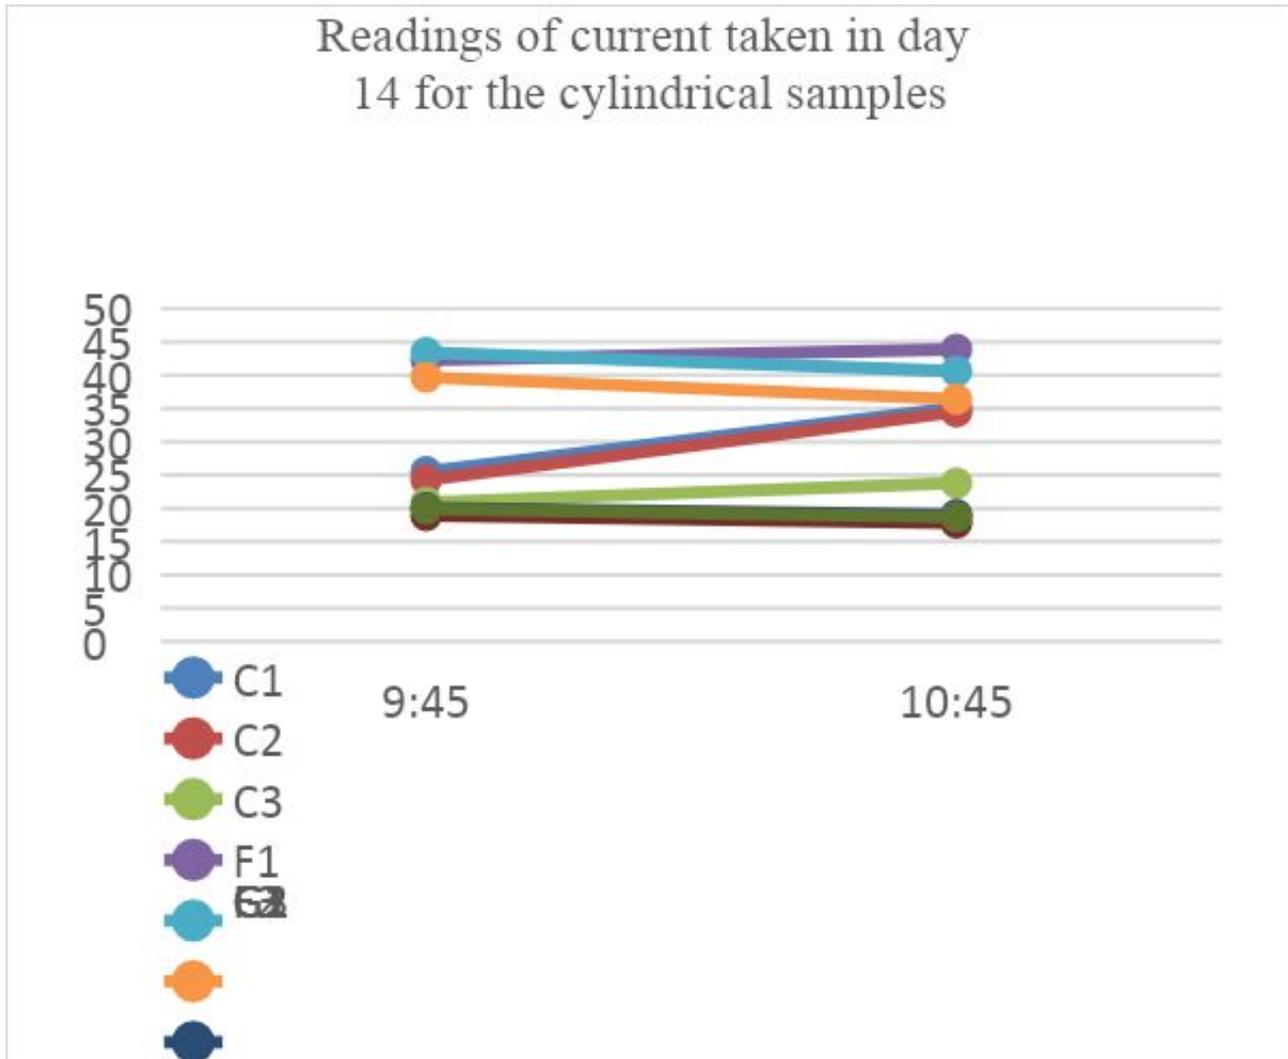
Figure 4. Readings of current taken in day 14 for the cylindrical samples

The above graph shows the reading of the current pass through the the three differently mix of normal concrete, fly ash and GGBFS which representing cylindrical specemens of 100mm*300mm. After completing two weeks excatly. The currrent passing through Normal concret sampel was 25.5 mA in the first hour and it incresee in the second hour and also the same with other two sampels and little rust is appeared on the sample specimens.. Fly ash show a considrable increase and has the highest current values amoung all the samples as the corrosion took a huge amount on the speciemns due to the chemical rection of the material and sodium chloride as well. GGBFS reading shows a small amount of decrease as there was no sign of corrosion in the samples.

The data below are taken for the sample mixes for normal concrete, fly ash and GGBSF. Nine cylindrical samples of 100mm*300mm has been tested in order to perform corrosion acceleration test. The data are representing the amount of current that are pass through the samples taken in 2 weeks in order to represent the amount of sodium chloride that penetrate into the samples when the time run.
